FORM B – BUILDING

Town Lexington

Address 79 North St.

Historic Name William Locke House

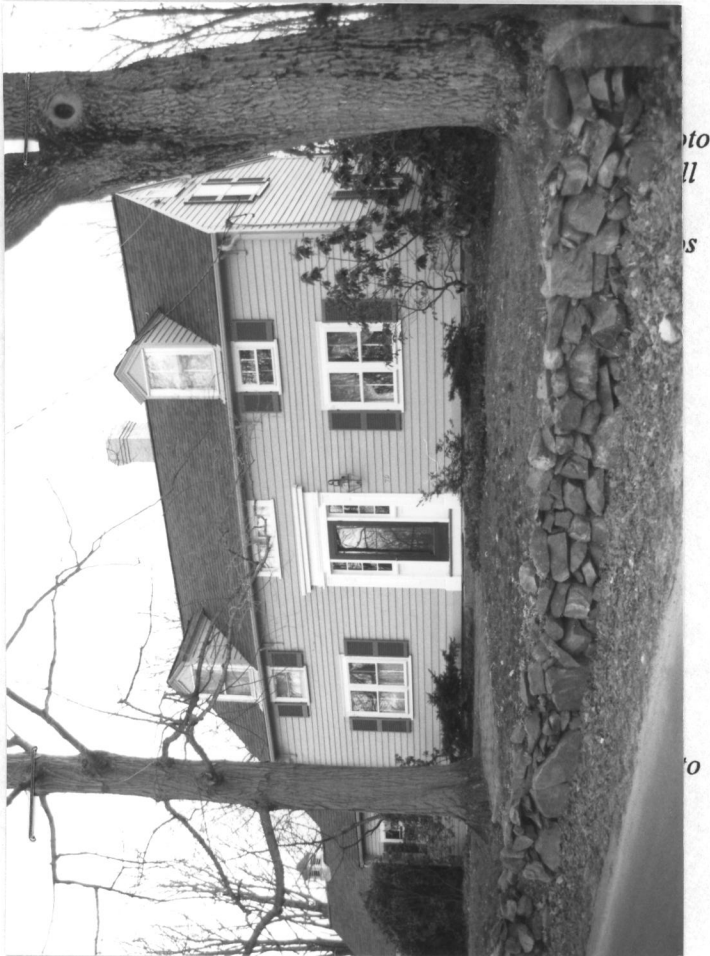
79 North St. is one of three side-gabled Greek Revival cottages in Lexington with wall dormers (the other two are at 241 Grove St. [MHC #748] and 185 Burlington St. [MHC #745]), although in this case the dormers appear to have been added above the eyebrow windows instead of being integral wall dormers. The original house is rectangular, 1½ stories, three-by-one bays, and side-gabled with a center rear chimney. It is set on a fieldstone foundation, clad with wood clapboards, and roofed with asphalt shingles. At the east end is a side-gabled addition with a ridge chimney and at the rear a long front-gabled addition. A breezeway connects the side addition and the two-car garage. The center entrance in the main block has an elaborate surround with a molded cornice, half-length sidelights, and side pilasters with a Greek fret design similar to that at 241 Grove St. (MHC #748), on a number of houses on Massachusetts Ave. in East Lexington, and in Pl. 28 of Asher Benjamin's *Practical House Carpenter*. Most windows are 2/2 double hung sash.
